**The Cranbrook House and Gardens:
East Pavilion (Thistle Shop)**

**39221 Woodward Avenue, Bloomfield Hills
Oakland County, MI. 48303**

Historic Preservation 572

Fall 2010

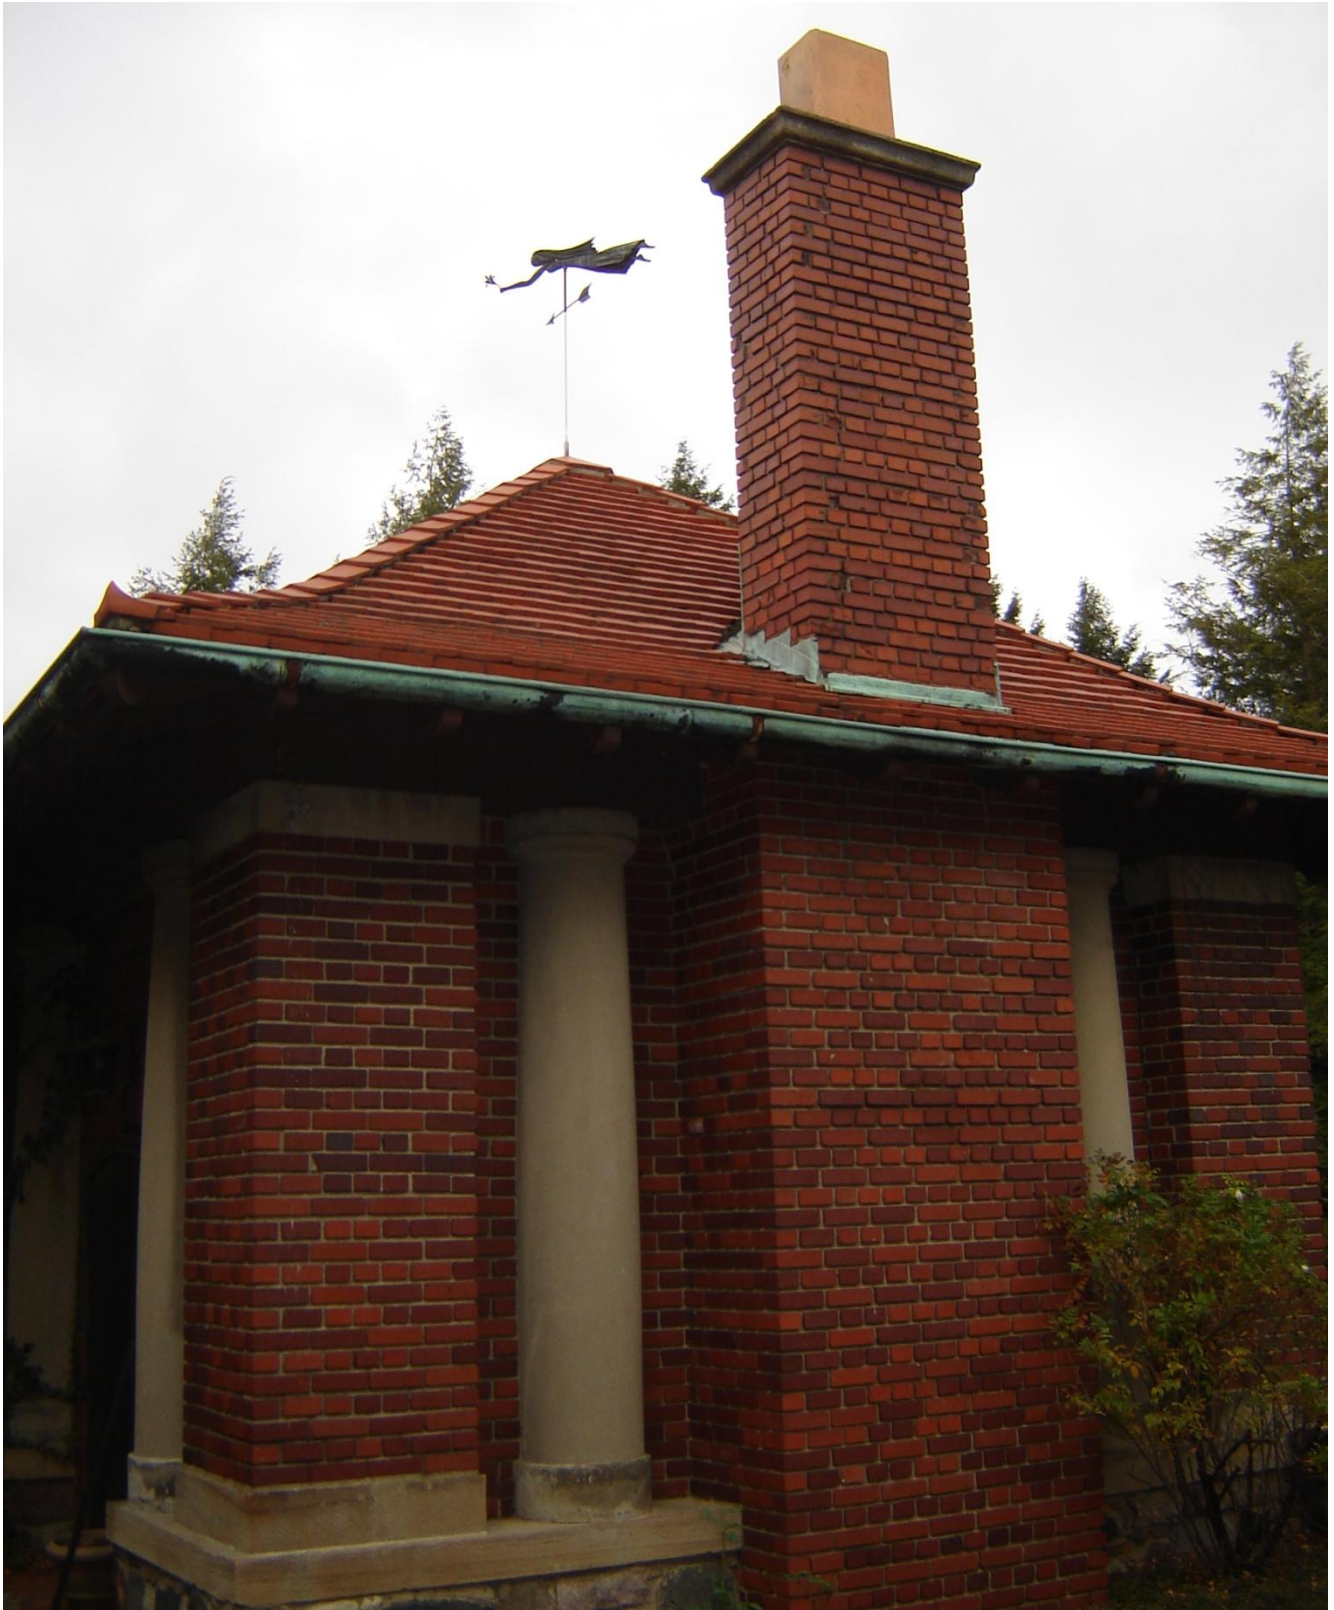
The chimney is in poor condition. The mortar damage is most prevalent here. There is also weathering of the bricks on its upper reaches, above the roofline. Brick replacement may be necessary, but this can easily be done by the rearrangement of the bricks facing inward towards the roof.

View of the pavilion looking north (some brick repair may be needed on the upper chimney)

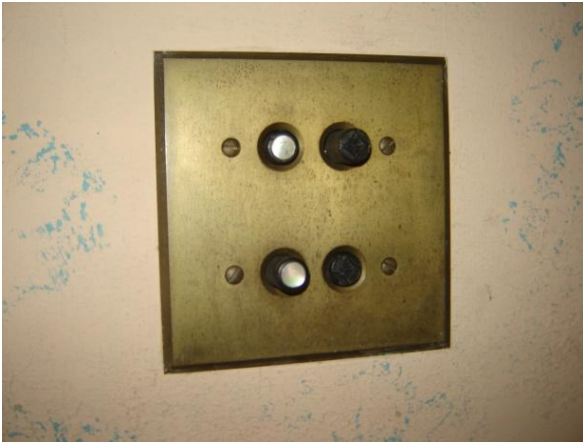
The electrical system is mainly characterized by an electrical conduit extending from the main house into the studio. Therefore, the installation of functioning electrical provisions should be easily resolved. The interior light fixtures still work, but there was suspicion that it was at one time painted and therefore it needs to be determined whether it only requires cleaning or if it needs to be repainted. The exterior fixture has fallen into disrepair but is still functioning. It does require some replacement of missing glass.

Condition of electrical (some updates needed)

Rehabilitation: Cracks in the wall and in the door threshold will be repaired similar to their original form. The electrical systems will be updated and replaced with up to date outlets. A cable will be fed through the underground electrical conduit tube, for internet accessibility. The fireplace will be rehabilitated and tap into its existing gas supply to allow for beauty and supplemental heat during colder months.

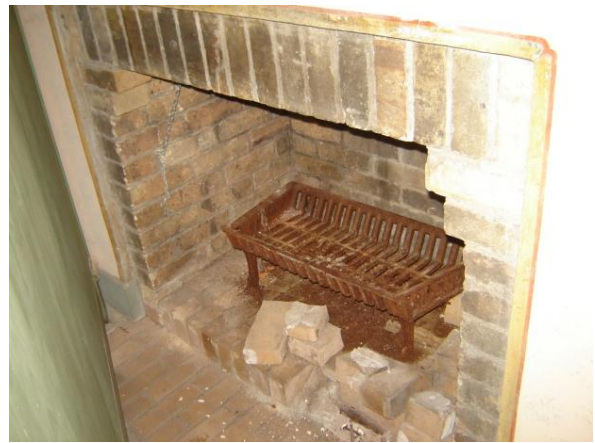
The fireplace needs to be rehabilitated, as brick has been dismantled. It also requires extensive cleaning due to staining from previous use. The mortar between the bricks is cracking in multiple places as a result of the same misdirected irrigation system. Due to this the interior of the chimney is in need of repair. The functionality of the flue was not tested, but is most likely in working condition. The detail around the fireplace should be repainted as the craftsmanship seems similar quality to that of Henry Booth's decorative paintings within the Cranbrook House.

Existing fireplace with brickwork

Discussion: The cracks in the walls will be patched and repainted with paint that keeps the same character and integrity of the original existing paint. The cracks in the threshold will be patched or replaced if needed. The electrical will be outfitted and updated to withstand electrical surges and avoid fuse blowouts. The existing gas line will be connected and gas logs will be put in. The painted detail surrounding the fireplace will need to be protected and repaired in places. The bricks on the threshold of the fireplace need to be secured and re-mortared.

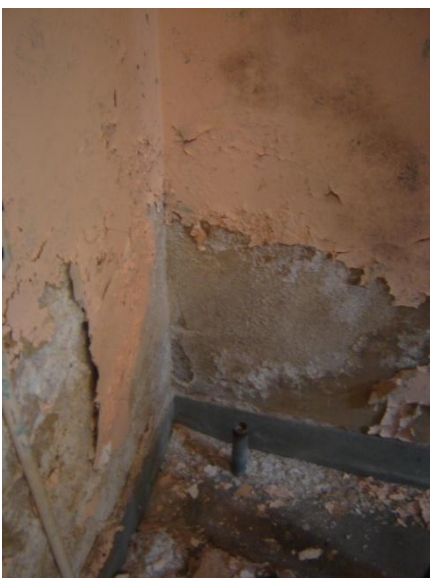
Corroded southwest wall

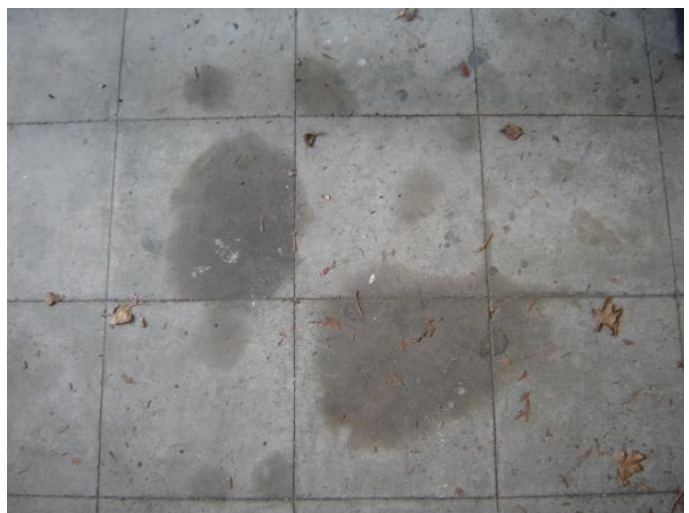
Oil stains on the concrete tiled floor

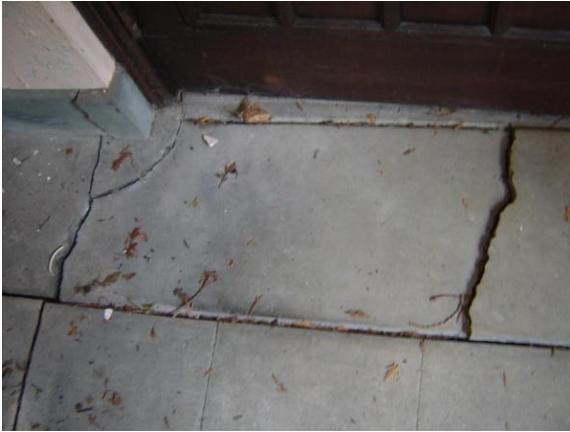
The threshold in the doorway has a large fracture, most likely due to drainage issues from the irrigation system affecting the foundation of the structure. The flooring is constructed of concrete blocks and is original, but shows signs of staining, speculated to be oil stains. The floors would therefore need to be cleaned. The construction has remained level however, and therefore no extensive repairs or replacement is necessary in terms of the foundation.

Damage in the entrance threshold

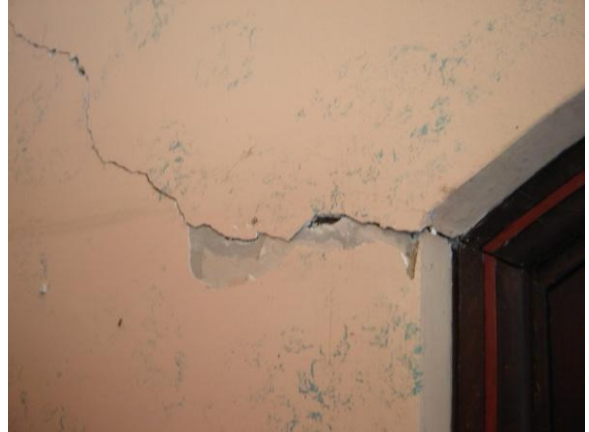
Crack above the door

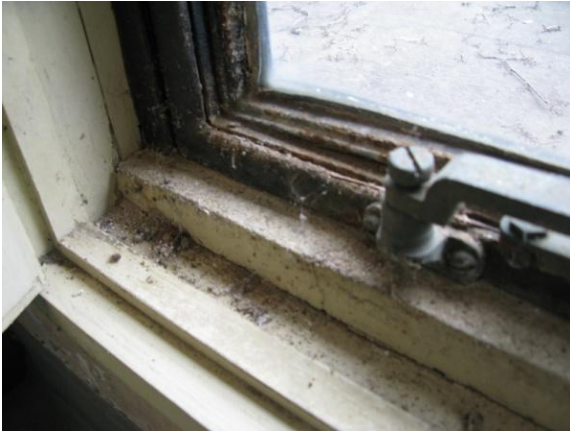
The interior framing and steel molding of the windows needs to be replaced in the same manner as mentioned for the exterior windows. Hardware systems are still in working condition, but hinges may need to be cleaned or replaced.

Rust damage in the north window hardware

Rehabilitation: The window hardware will need to be repaired and cleaned. New panes of glass will need to be added in a few places. The door will need to be cleaned and protected from the elements. Any damage to the wood will be properly replaced and not take away from the original character. The existing screen door will need to be extensively repaired because of its bad condition. The roof is in great condition. However, some of the mortar in the joints between the tiled roof will need to be replaced. The brickwork has survived the years in most places however; the upper part of the chimney has suffered damage through the years. It is recommended that the brick work is replaced in some areas. The drainage system needs to be fixed in some areas.

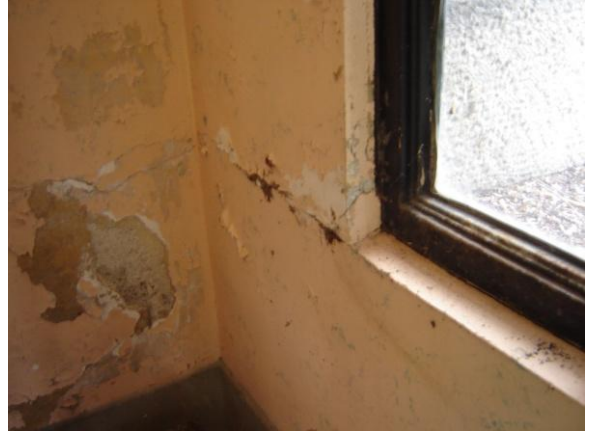
As stated before, the interior is in relatively good condition. The walls should probably be repainted. The current paint is 36 years old, and it is undetermined as original or a modification carried out by the Auxiliary. There is also a layer of efflorescence in the southwest corner, due to water damage from the irrigation systems. The plaster is cracking and the paint has peeled away from the wall, therefore, repair is necessary.

Damaged paint and plaster northwest corner

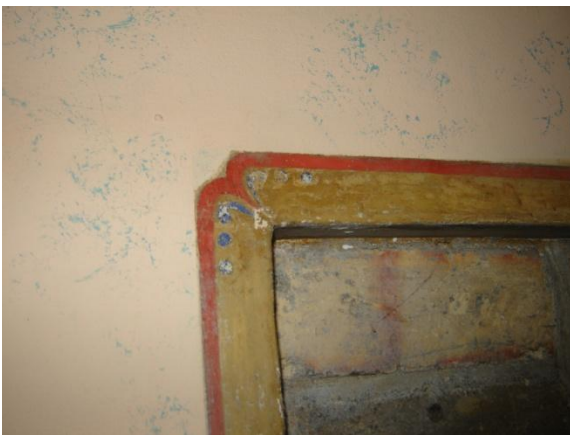
Detail around fireplace

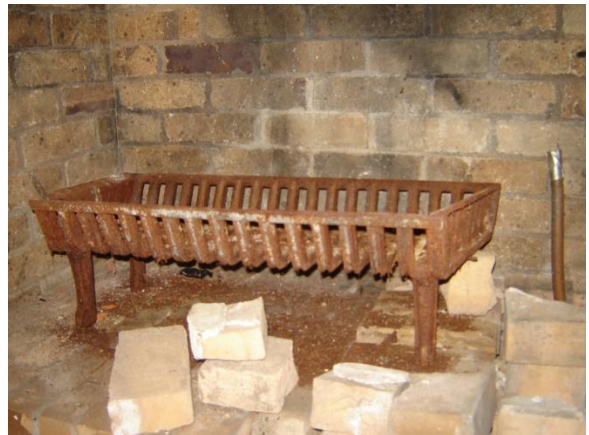
The fireplace has a gas line, but it is undetermined whether or not it is still functioning. If such is the case the only change needed is the re-installation of fixtures. The mechanical systems of the windows have slight rust and corrosion, and therefore may require gentle cleaning or replacement. It is unknown if the flue works, but in all likelihood it requires cleaning.

Fireplace with gas hookup
